# HISTORICAL AND ARCHITECTURAL RESOURCES OF AMES, IOWA

Reconnaissance Survey

Intensive Survey of the Central Business District

WILLIAM C. PAGE, PUBLIC HISTORIAN  
DUNBAR/JONES PARTNERSHIP

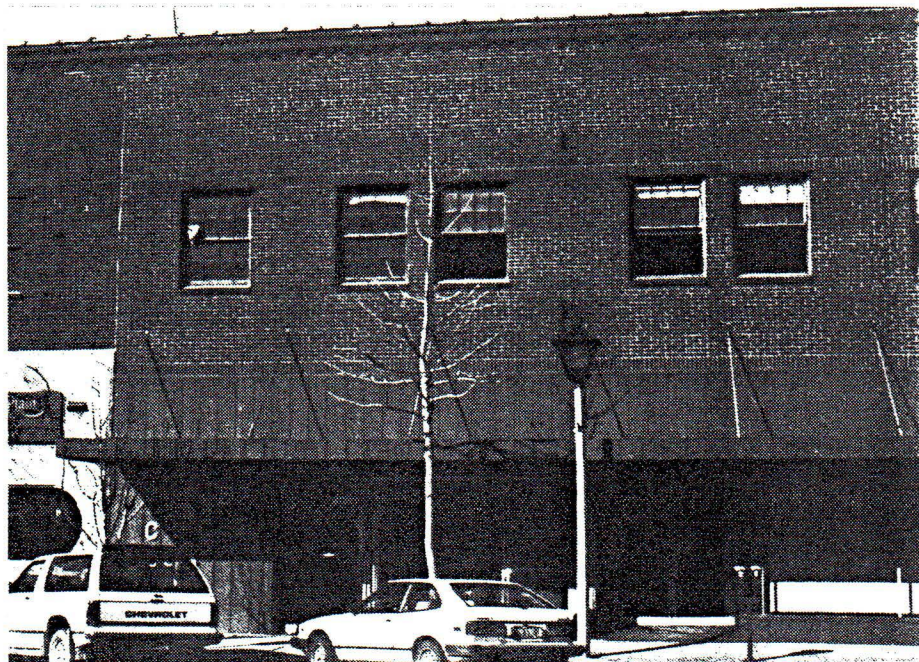
This is an outstanding building in terms of restrained commercial design and integrity. The facelift for this building might have been architect designed but it also could be the work of a local building contractor. In any event, it would be a contributing/key building in an historic district. This two-room commercial building might be counted as two separate buildings in a National Register application depending on each unit's historic uses.

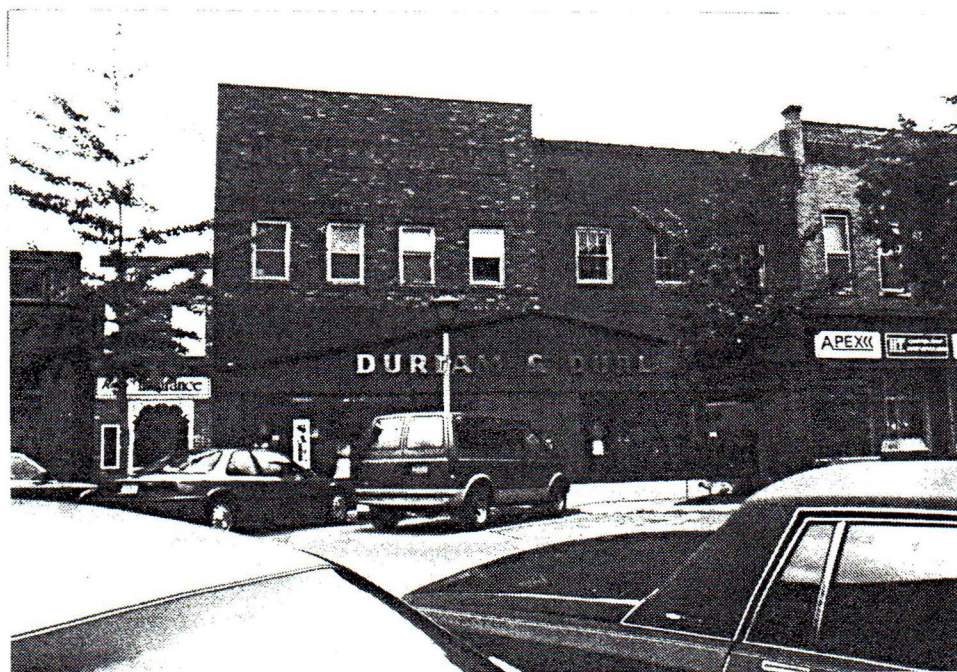
This building is significant because it calls direct attention to the Face Lifts on Main movement, which swept Ames in the 'Teens, 1920s, and 1930s. The building could be contributing to an historic commercial district, particularly if the problem of the second floor windows can be addressed.

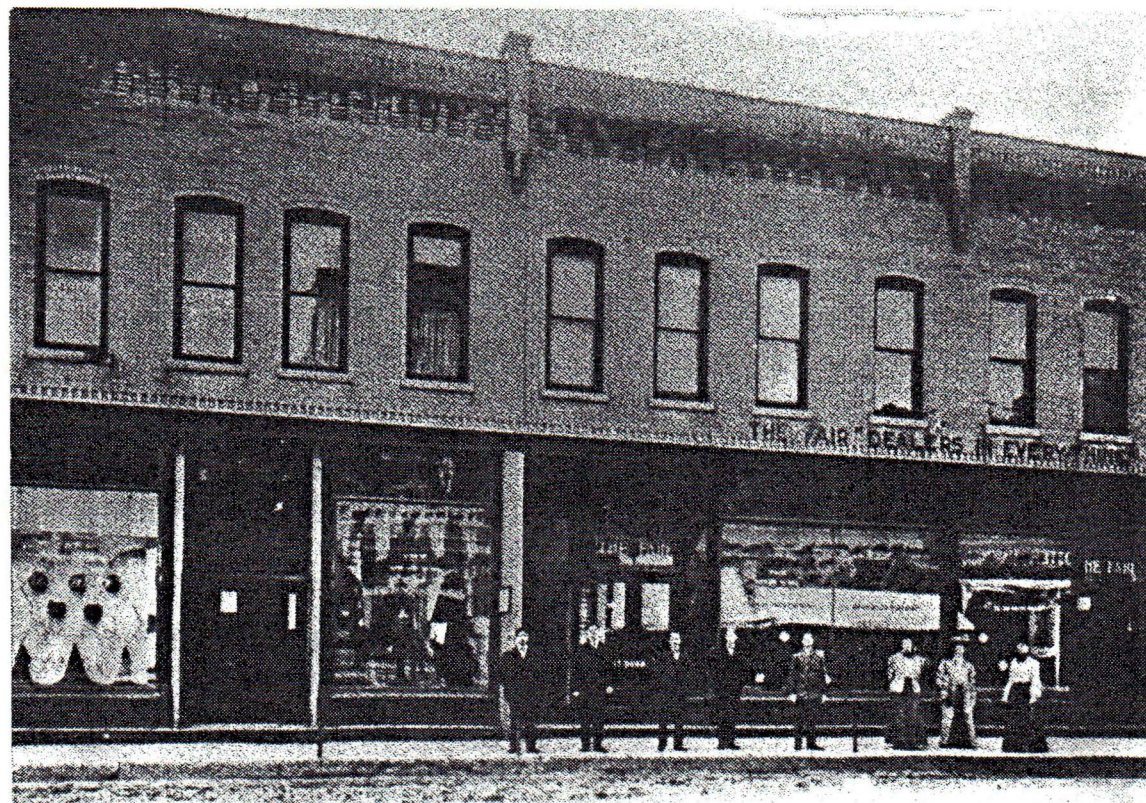
This commercial building and its association with the block at 232-234 Main Street constitute one of the finest commercial designs in the central business district. These buildings are significant for the breadth of their architectural design. The quality of its design and building materials suggests that it may have originally been constructed by the Masons to serve as their meeting hall, as well as an investment as rental property. This could be a key building in an historic commercial district.

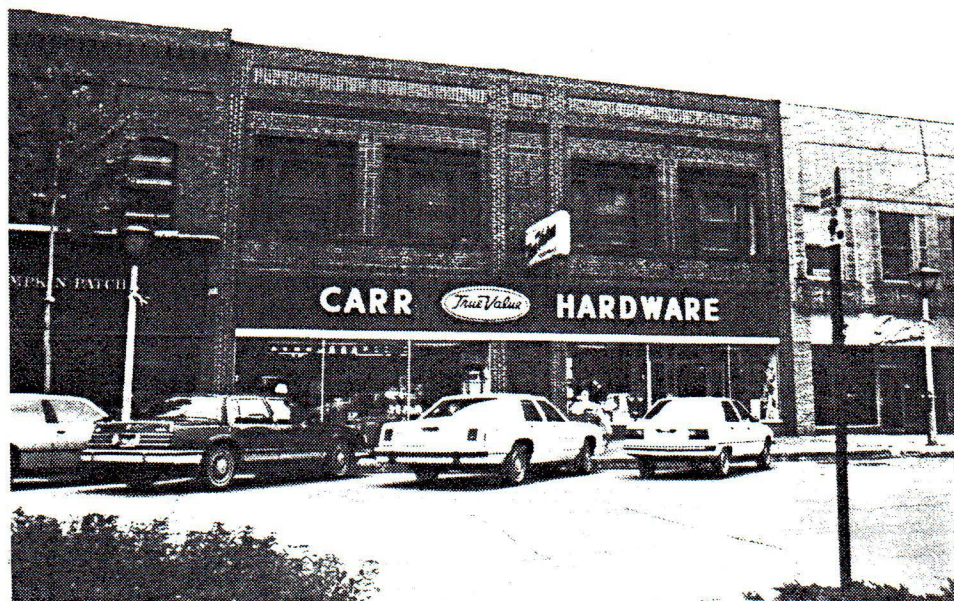
18. Map \_\_\_\_\_
19. Photo looking SW Photographer Wirth

17. Surroundings of the building: ☐ open land ☐ woodland ☐ scattered outbuildings ☐ densely built-up ☒ commercial  
☐ industrial ☐ residential ☐ other \_\_\_\_\_

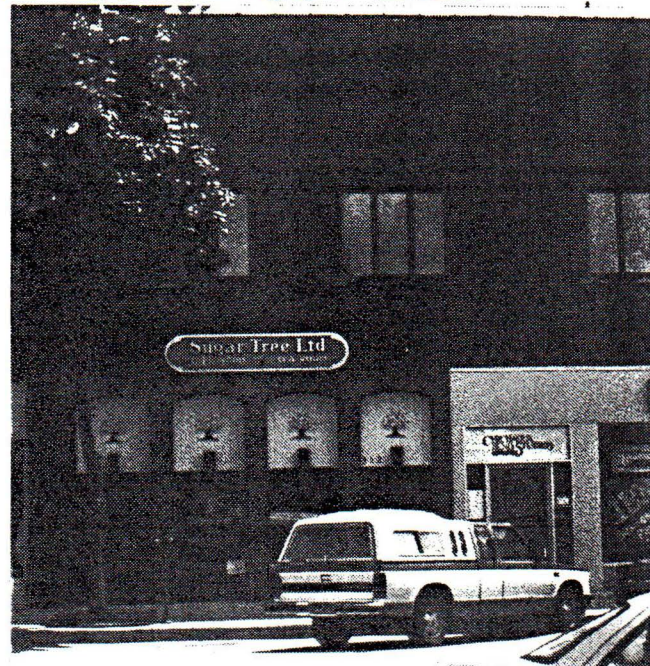
## 19. Photo looking S Photographer Wirth

13. Condition: ☐ excellent ☒ good ☐ fair ☐ deteriorated
14. Integrity: ☒ original site ☐ moved--if so, when? \_\_\_\_\_  
Notes on alterations, additions (with dates and architect, if known) and any other notable features of building and site:  
\_\_\_\_\_(see next page)

A 1930s date for the design of the facade is commensurate with its physical appearance. The building features two brickworked bands below the parapet area and lintels for the second floor windows which extend across the entire face of the building as stringcourses. The area directly above the storefront also has a stringcourse across the facade. The second floor windows are replacements. The three-paned vertical configuration injects a discordant note to this area. The building most likely had, originally, a small paned window configuration on the second floor. The building at 125-127 Main, which this building greatly resembles, has retained its original second floor windows, and a similar design was probably also in place at 312-314.

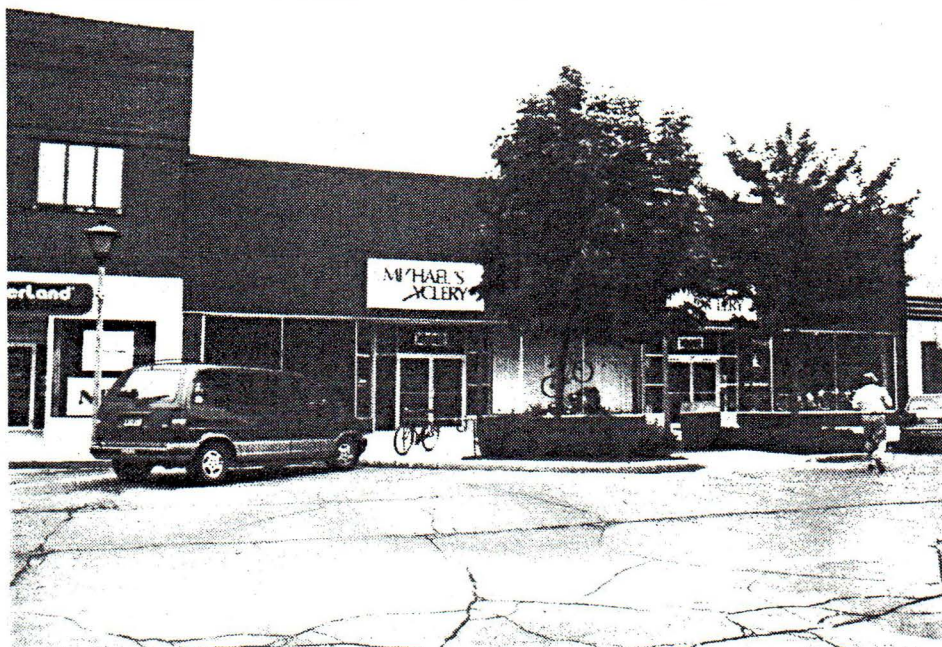
19. Photo looking SW Photographer Wirth

13. Condition: ☐ excellent ☒ good ☐ fair ☐ deteriorated  
14. Integrity: ☒ original site ☐ moved--if so, when? \_\_\_\_\_  
Notes on alterations, additions (with dates and architect, if known) and any other notable features of building and site:  
\_\_\_\_\_(see next page)

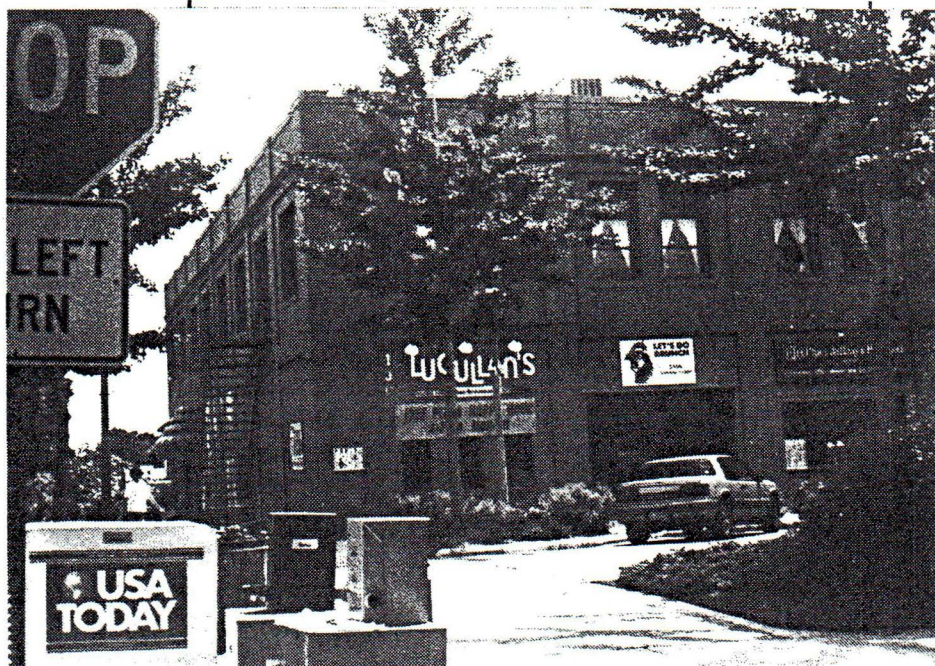
19. Photo looking S Photographer Wirth

13. Condition: ☐ excellent ☒ good ☐ fair ☐ deteriorated
14. Integrity: ☒ original site ☐ moved--if so, when? \_\_\_\_\_  
Notes on alterations, additions (with dates and architect, if known) and any other notable features of building and site:  
(see next page)

The integrity of this building remains high. Although the three bays on the storefront have been altered, they respect the original cavities. Windows on the second floor on the east elevation are 1/1 double hung sash and appear to be original to the building.

This building would be contributing/key to an historic commercial district because it calls attention to an important new engineering technology of the first quarter of the Twentieth Century. This building appears to be the first building in the central business district which employs concrete products. As such, it might have established a precedent for the use of stucco on commercial buildings, such as the facelifts at 131, 201, and 233 Main Street.

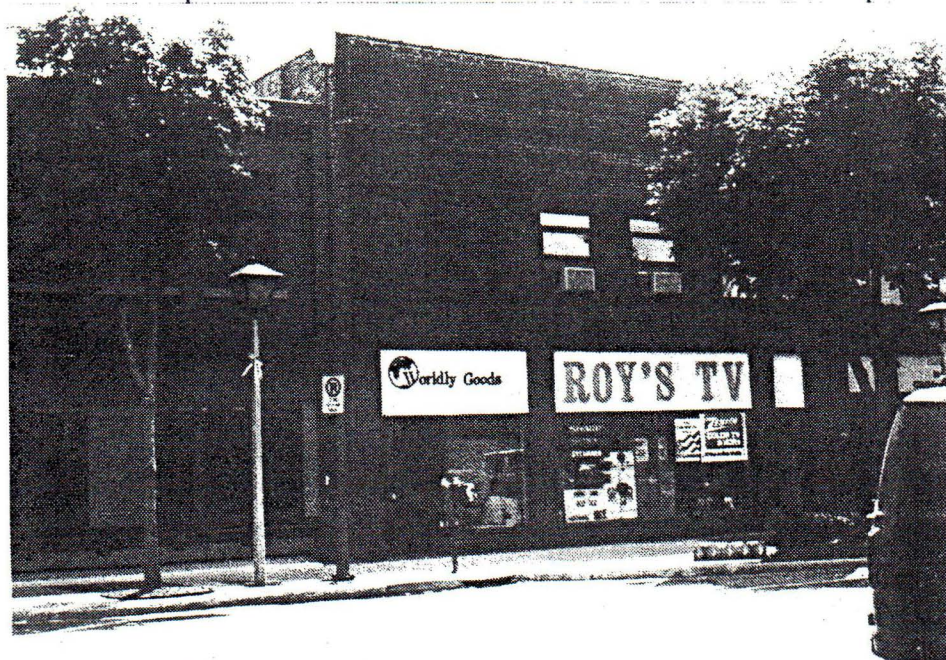
18. Map \_\_\_\_\_  
19. Photo looking S Photographer Wirth

13. Condition: ☐ excellent ☒ good ☐ fair ☐ deteriorated  
14. Integrity: ☒ original site ☐ moved--if so, when? \_\_\_\_\_  
Notes on alterations, additions (with dates and architect, if known) and any other notable features of building and site:  
(see next page)

17. Surroundings of the building: ☐ open land ☐ woodland ☐ scattered outbuildings ☐ densely built-up ☒ commercial  
☐ industrial ☐ residential ☐ other \_\_\_\_\_

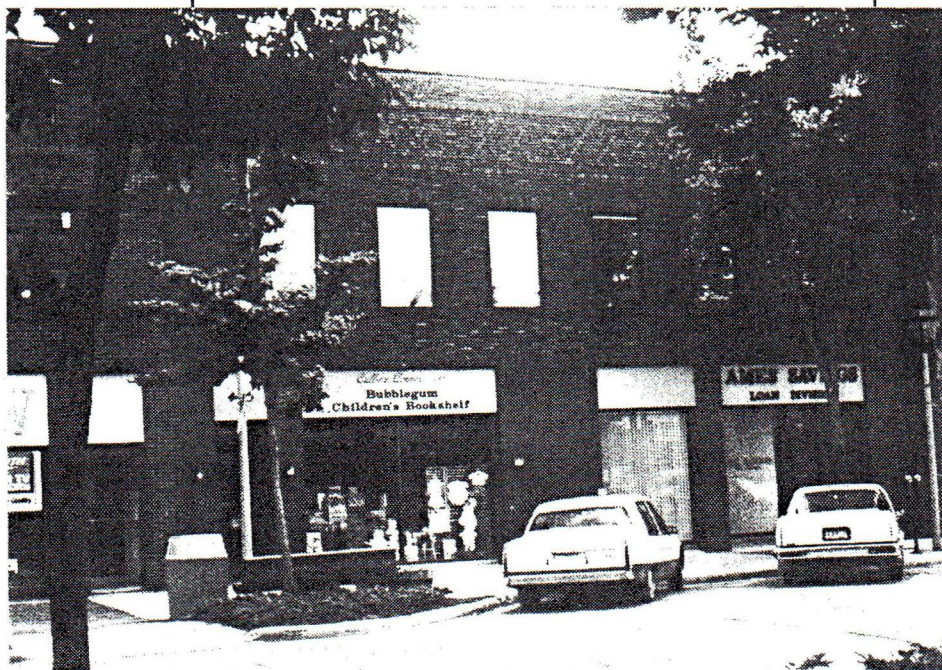
18. Map \_\_\_\_\_
19. Photo looking S Photographer Wirth

13. Condition: ☐ excellent ☒ good ☐ fair ☐ deteriorated
14. Integrity: ☒ original site ☐ moved--if so, when? \_\_\_\_\_  
Notes on alterations, additions (with dates and architect, if known) and any other notable features of building and site:  
(see next page)

17. Surroundings of the building: ☐ open land ☐ woodland ☐ scattered outbuildings ☐ densely built-up ☒ commercial  
☐ industrial ☐ residential ☐ other \_\_\_\_\_

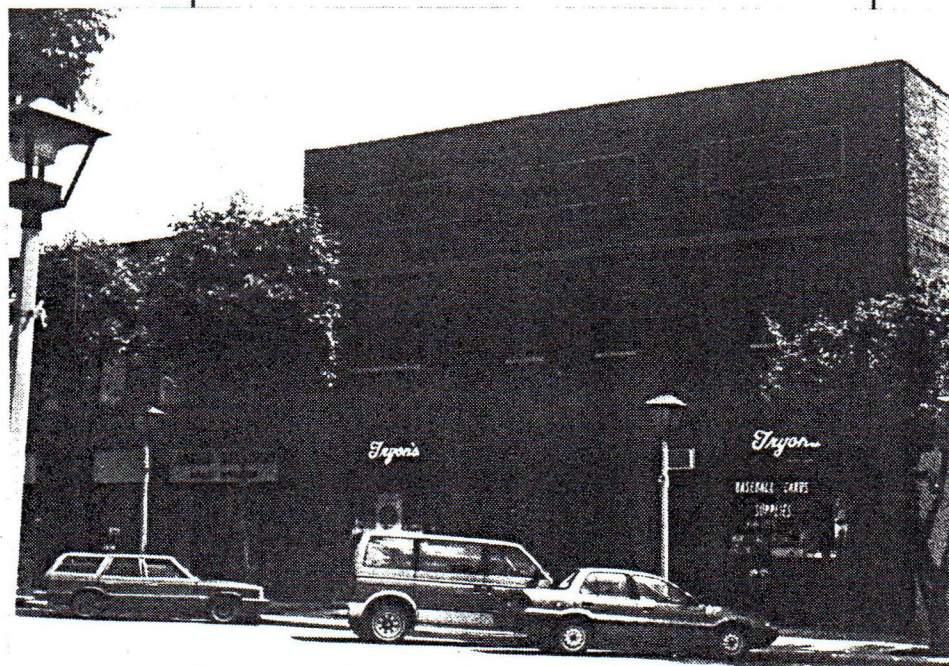
19. Photo looking S Photographer Wirth

13. Condition: ☐ excellent ☒ good ☐ fair ☐ deteriorated
14. Integrity: ☒ original site ☐ moved--if so, when? \_\_\_\_\_  
Notes on alterations, additions (with dates and architect, if known) and any other notable features of building and site:  
\_\_\_\_\_(see next page)

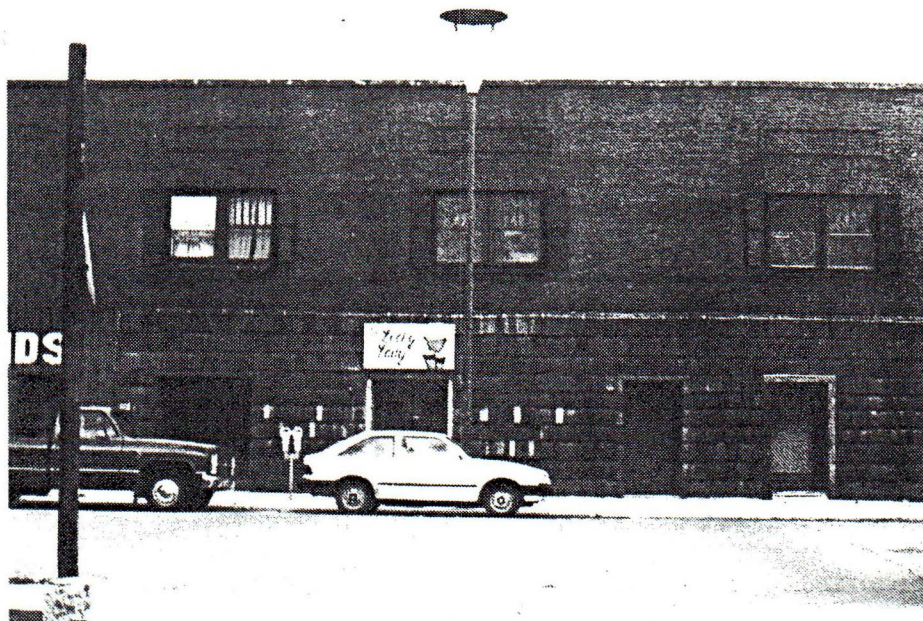
18. Map \_\_\_\_\_
19. Photo looking N Photographer Wirth

13. Condition: ☐ excellent ☒ good ☐ fair ☐ deteriorated
14. Integrity: ☒ original site ☐ moved--if so, when? \_\_\_\_\_  
Notes on alterations, additions (with dates and architect, if known) and any other notable features of building and site:  
\_\_\_\_\_(see next page)

17. Surroundings of the building: ☐ open land ☐ woodland ☐ scattered outbuildings ☐ densely built-up ☒ commercial  
☐ industrial ☐ residential ☐ other \_\_\_\_\_

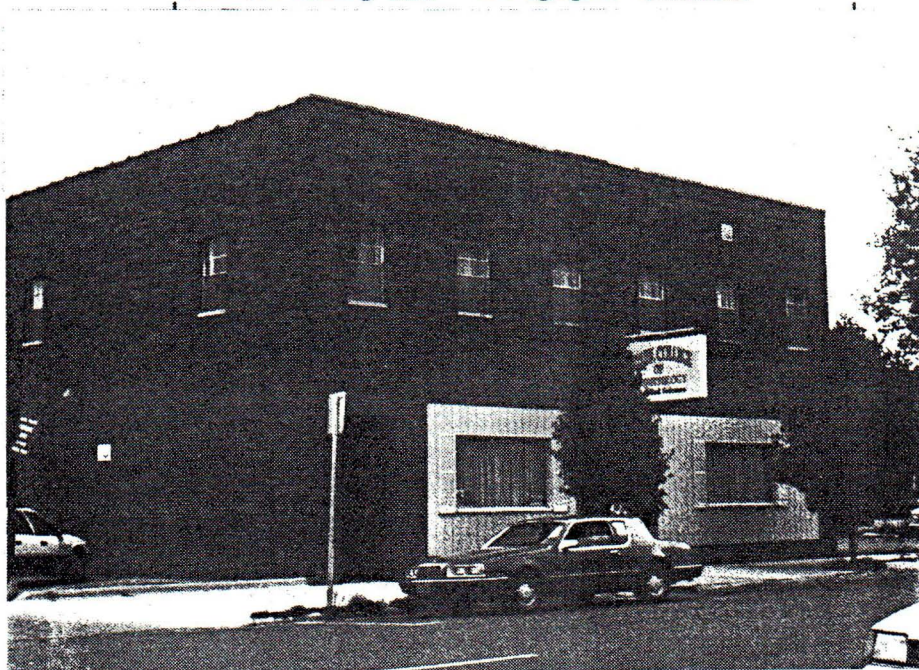
18. Map \_\_\_\_\_
19. Photo looking SW Photographer Wirth

17. Surroundings of the building: ☐ open land ☐ woodland ☐ scattered outbuildings ☐ densely built-up ☒ commercial  
☐ industrial ☐ residential ☐ other \_\_\_\_\_

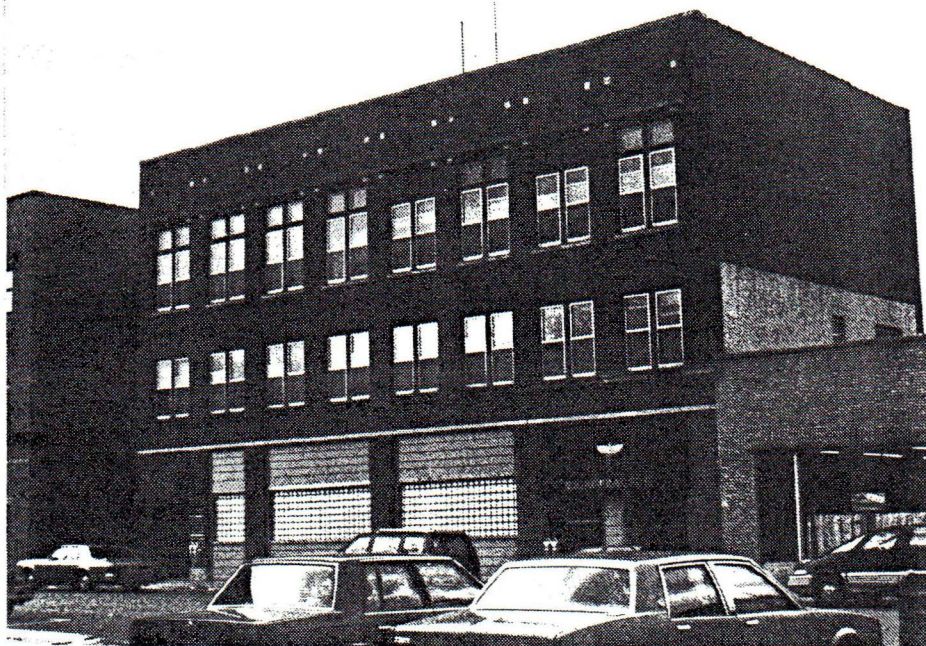
18. Map \_\_\_\_\_
19. Photo looking SE Photographer Wirth

17. Surroundings of the building: ☐ open land ☐ woodland ☐ scattered outbuildings ☐ densely built-up ☒ commercial  
☐ industrial ☐ residential ☐ other \_\_\_\_\_

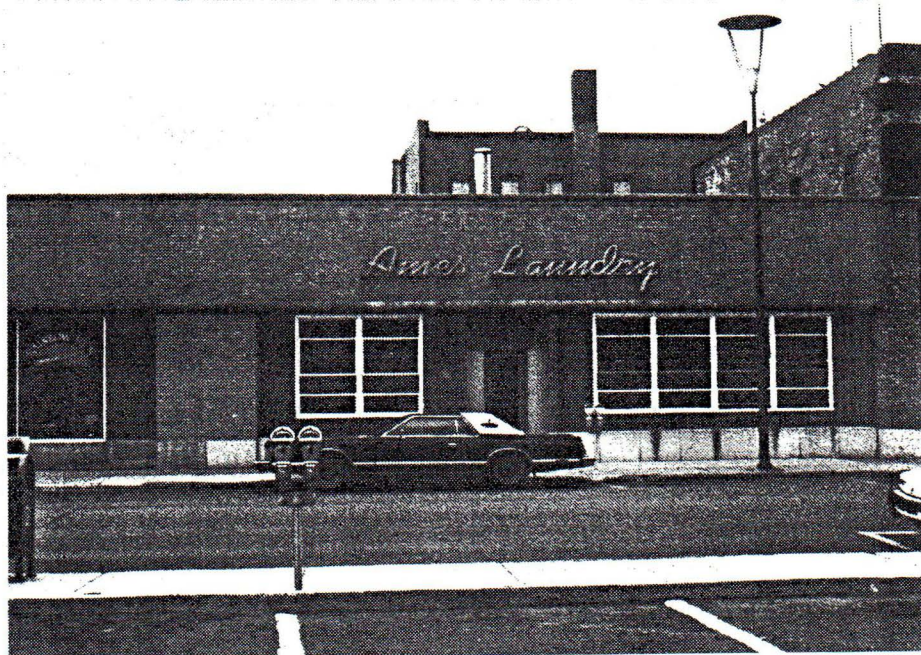
18. Map \_\_\_\_\_ 19. Photo looking S Photographer Wirth

17. Surroundings of the building: ☐ open land ☐ woodland ☐ scattered outbuildings ☐ densely built-up ☒ commercial  
☐ industrial ☐ residential ☐ other \_\_\_\_\_

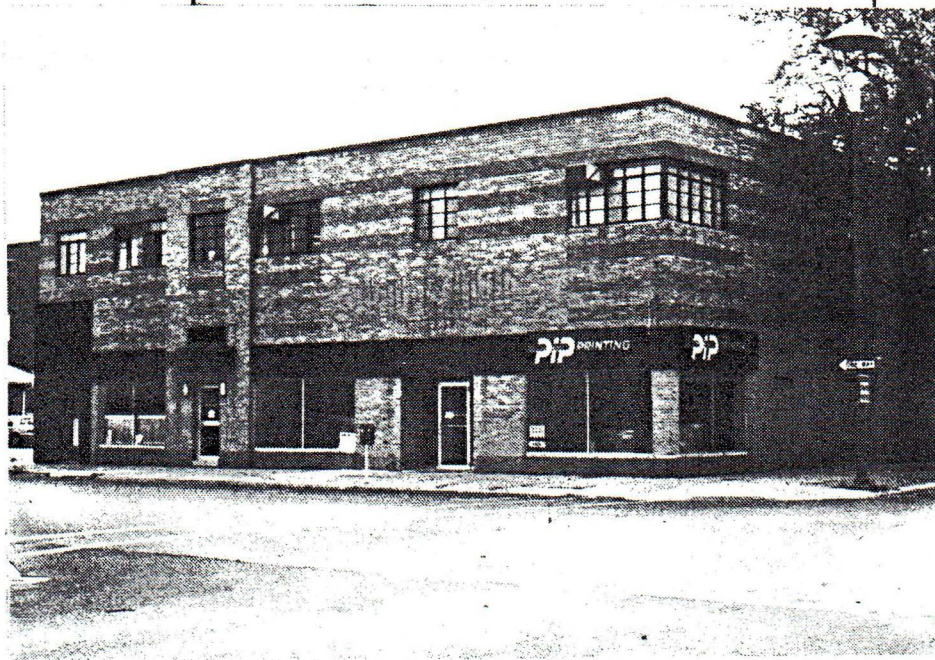
18. Map \_\_\_\_\_
19. Photo looking SE Photographer Wirth

17. Surroundings of the building: ☐ open land ☐ woodland ☐ scattered outbuildings ☐ densely built-up ☒ commercial  
☐ industrial ☐ residential ☐ other \_\_\_\_\_
